BURNS COOLEY DENNIS, INC.

Report No. 220228-1

Geotechnical Investigation Landslides at Huntington Lake Rankin County, Mississippi

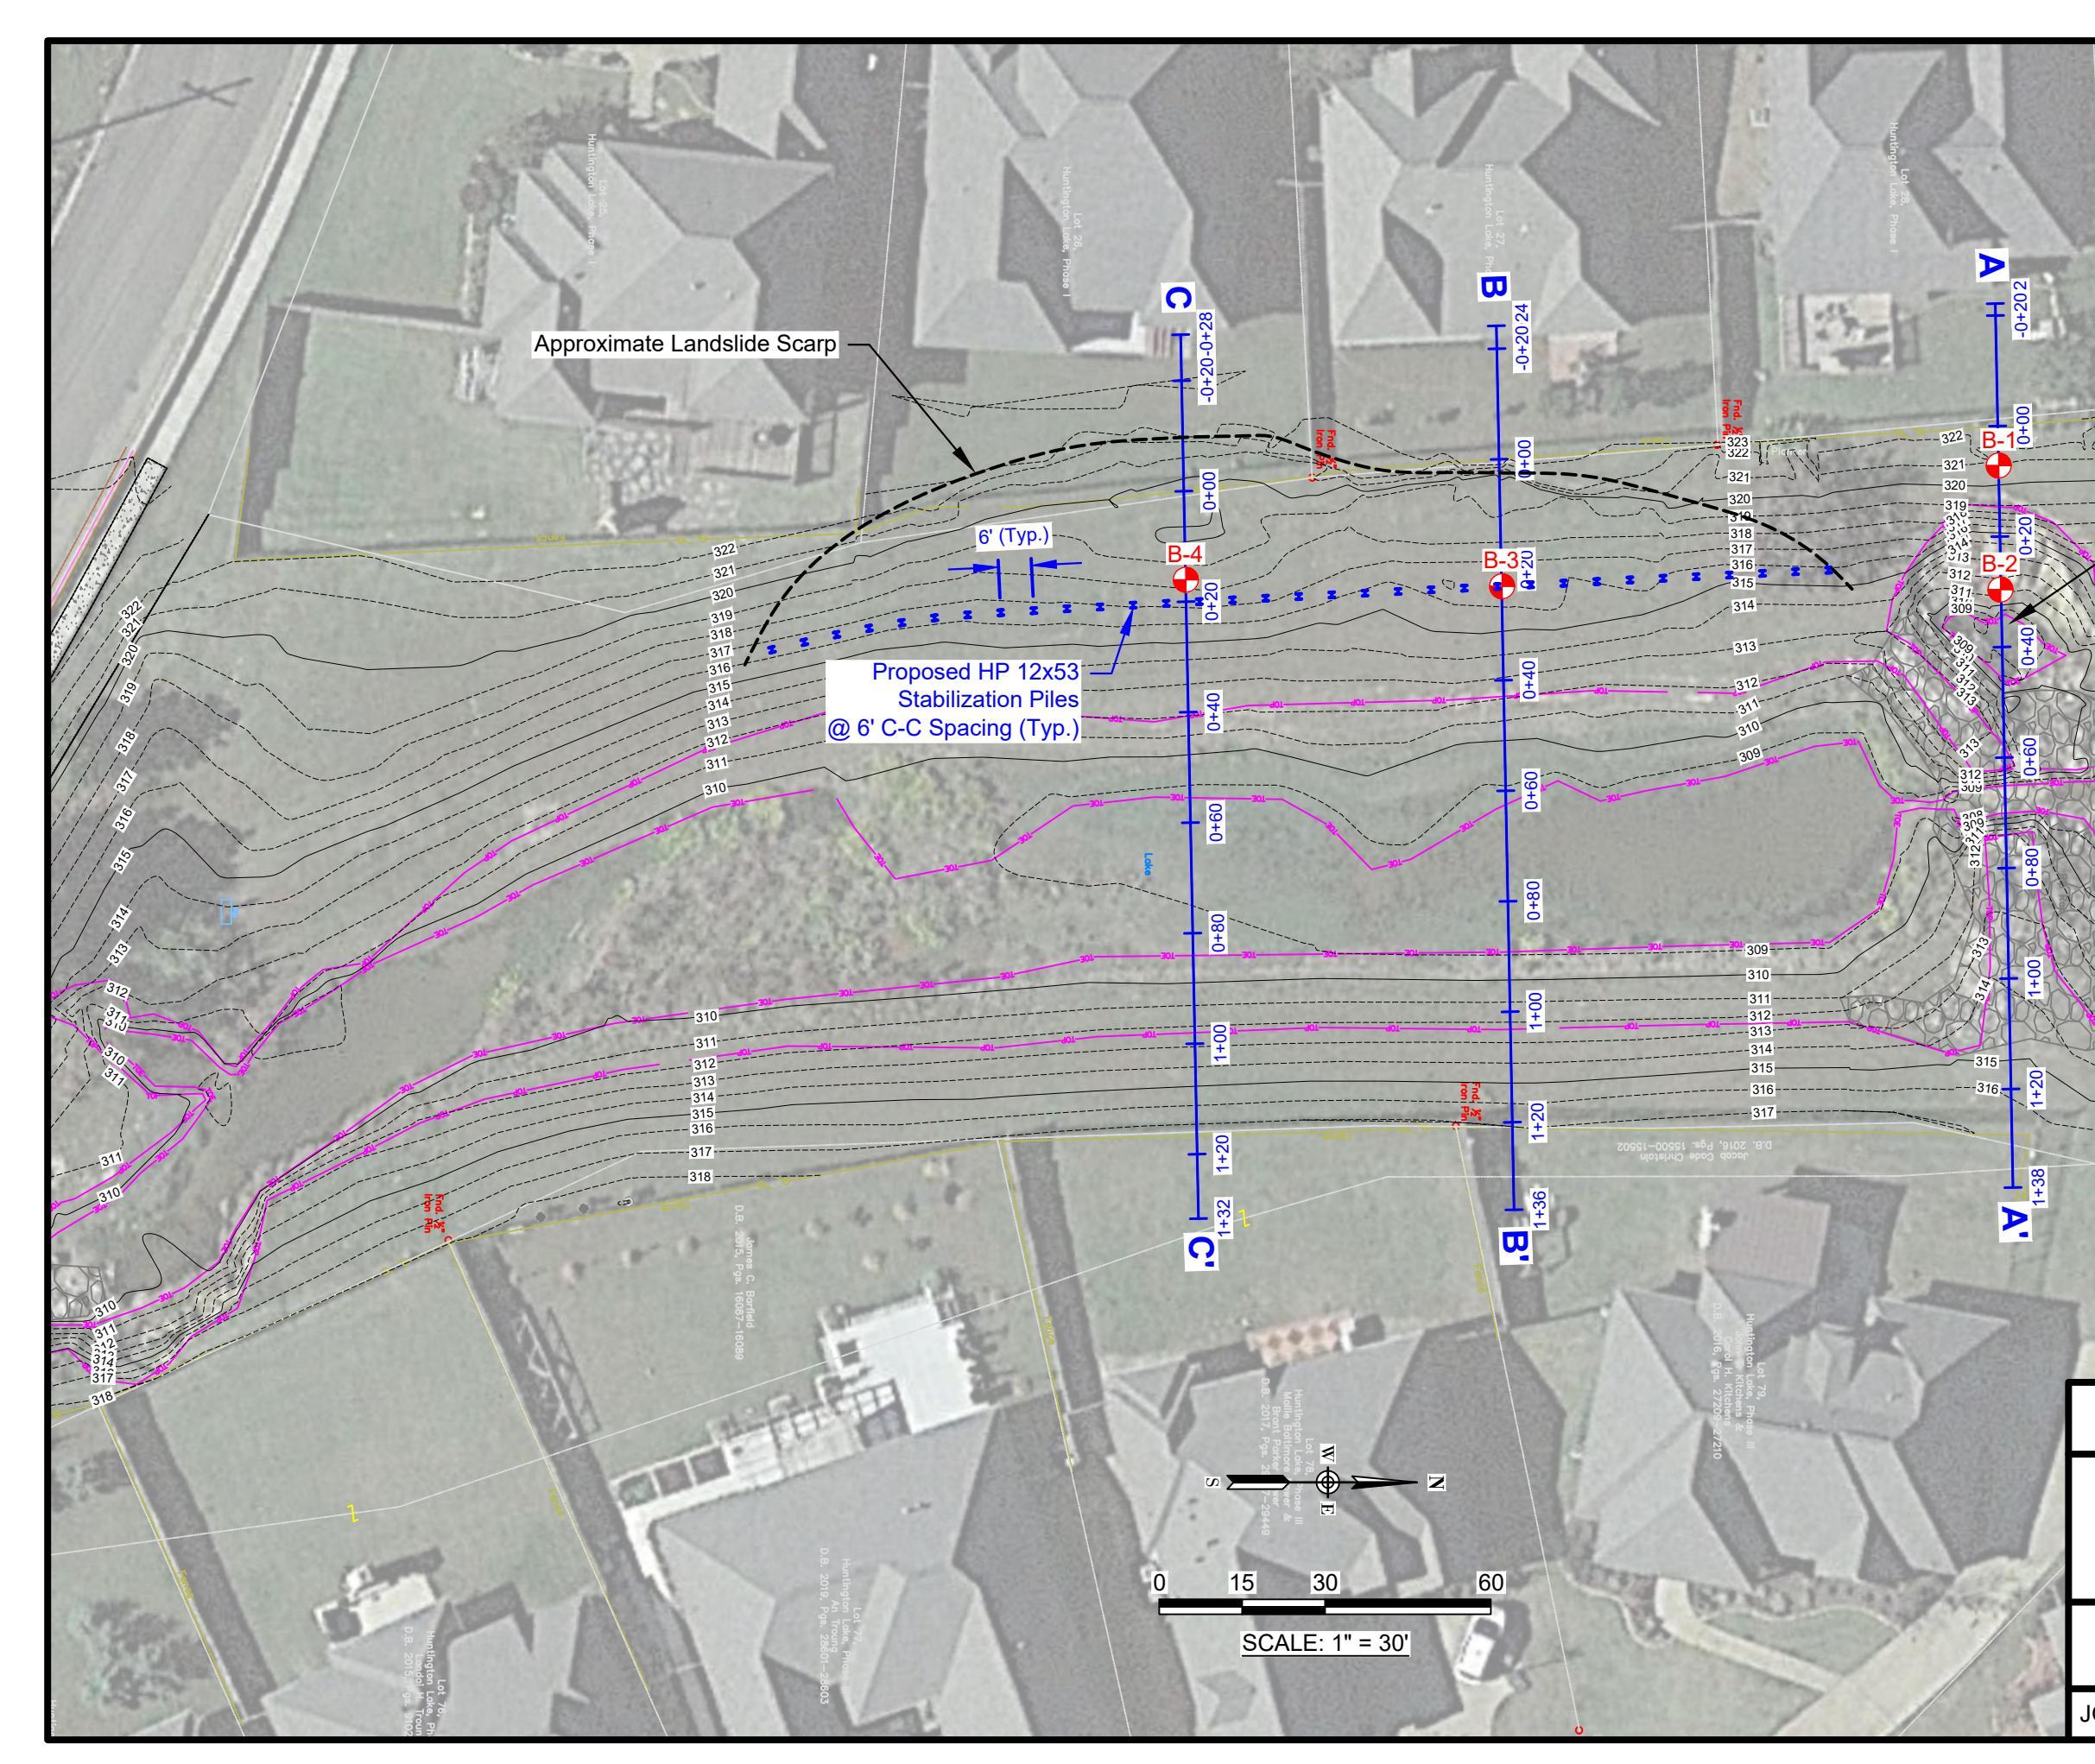
FIGURE 13

Figure 13 shows a plan view with the proposed minimum limits of HP 12x53 stabilization piles. These limits are based on our observations of current slope movements. However, the slope to the south, immediately east of the property at 100 Huntington View, is similar to the portion of the slope that has failed. It would be prudent to extend the limits of the stabilization piles further south to reduce the likelihood that this adjacent slope will fail in the future.

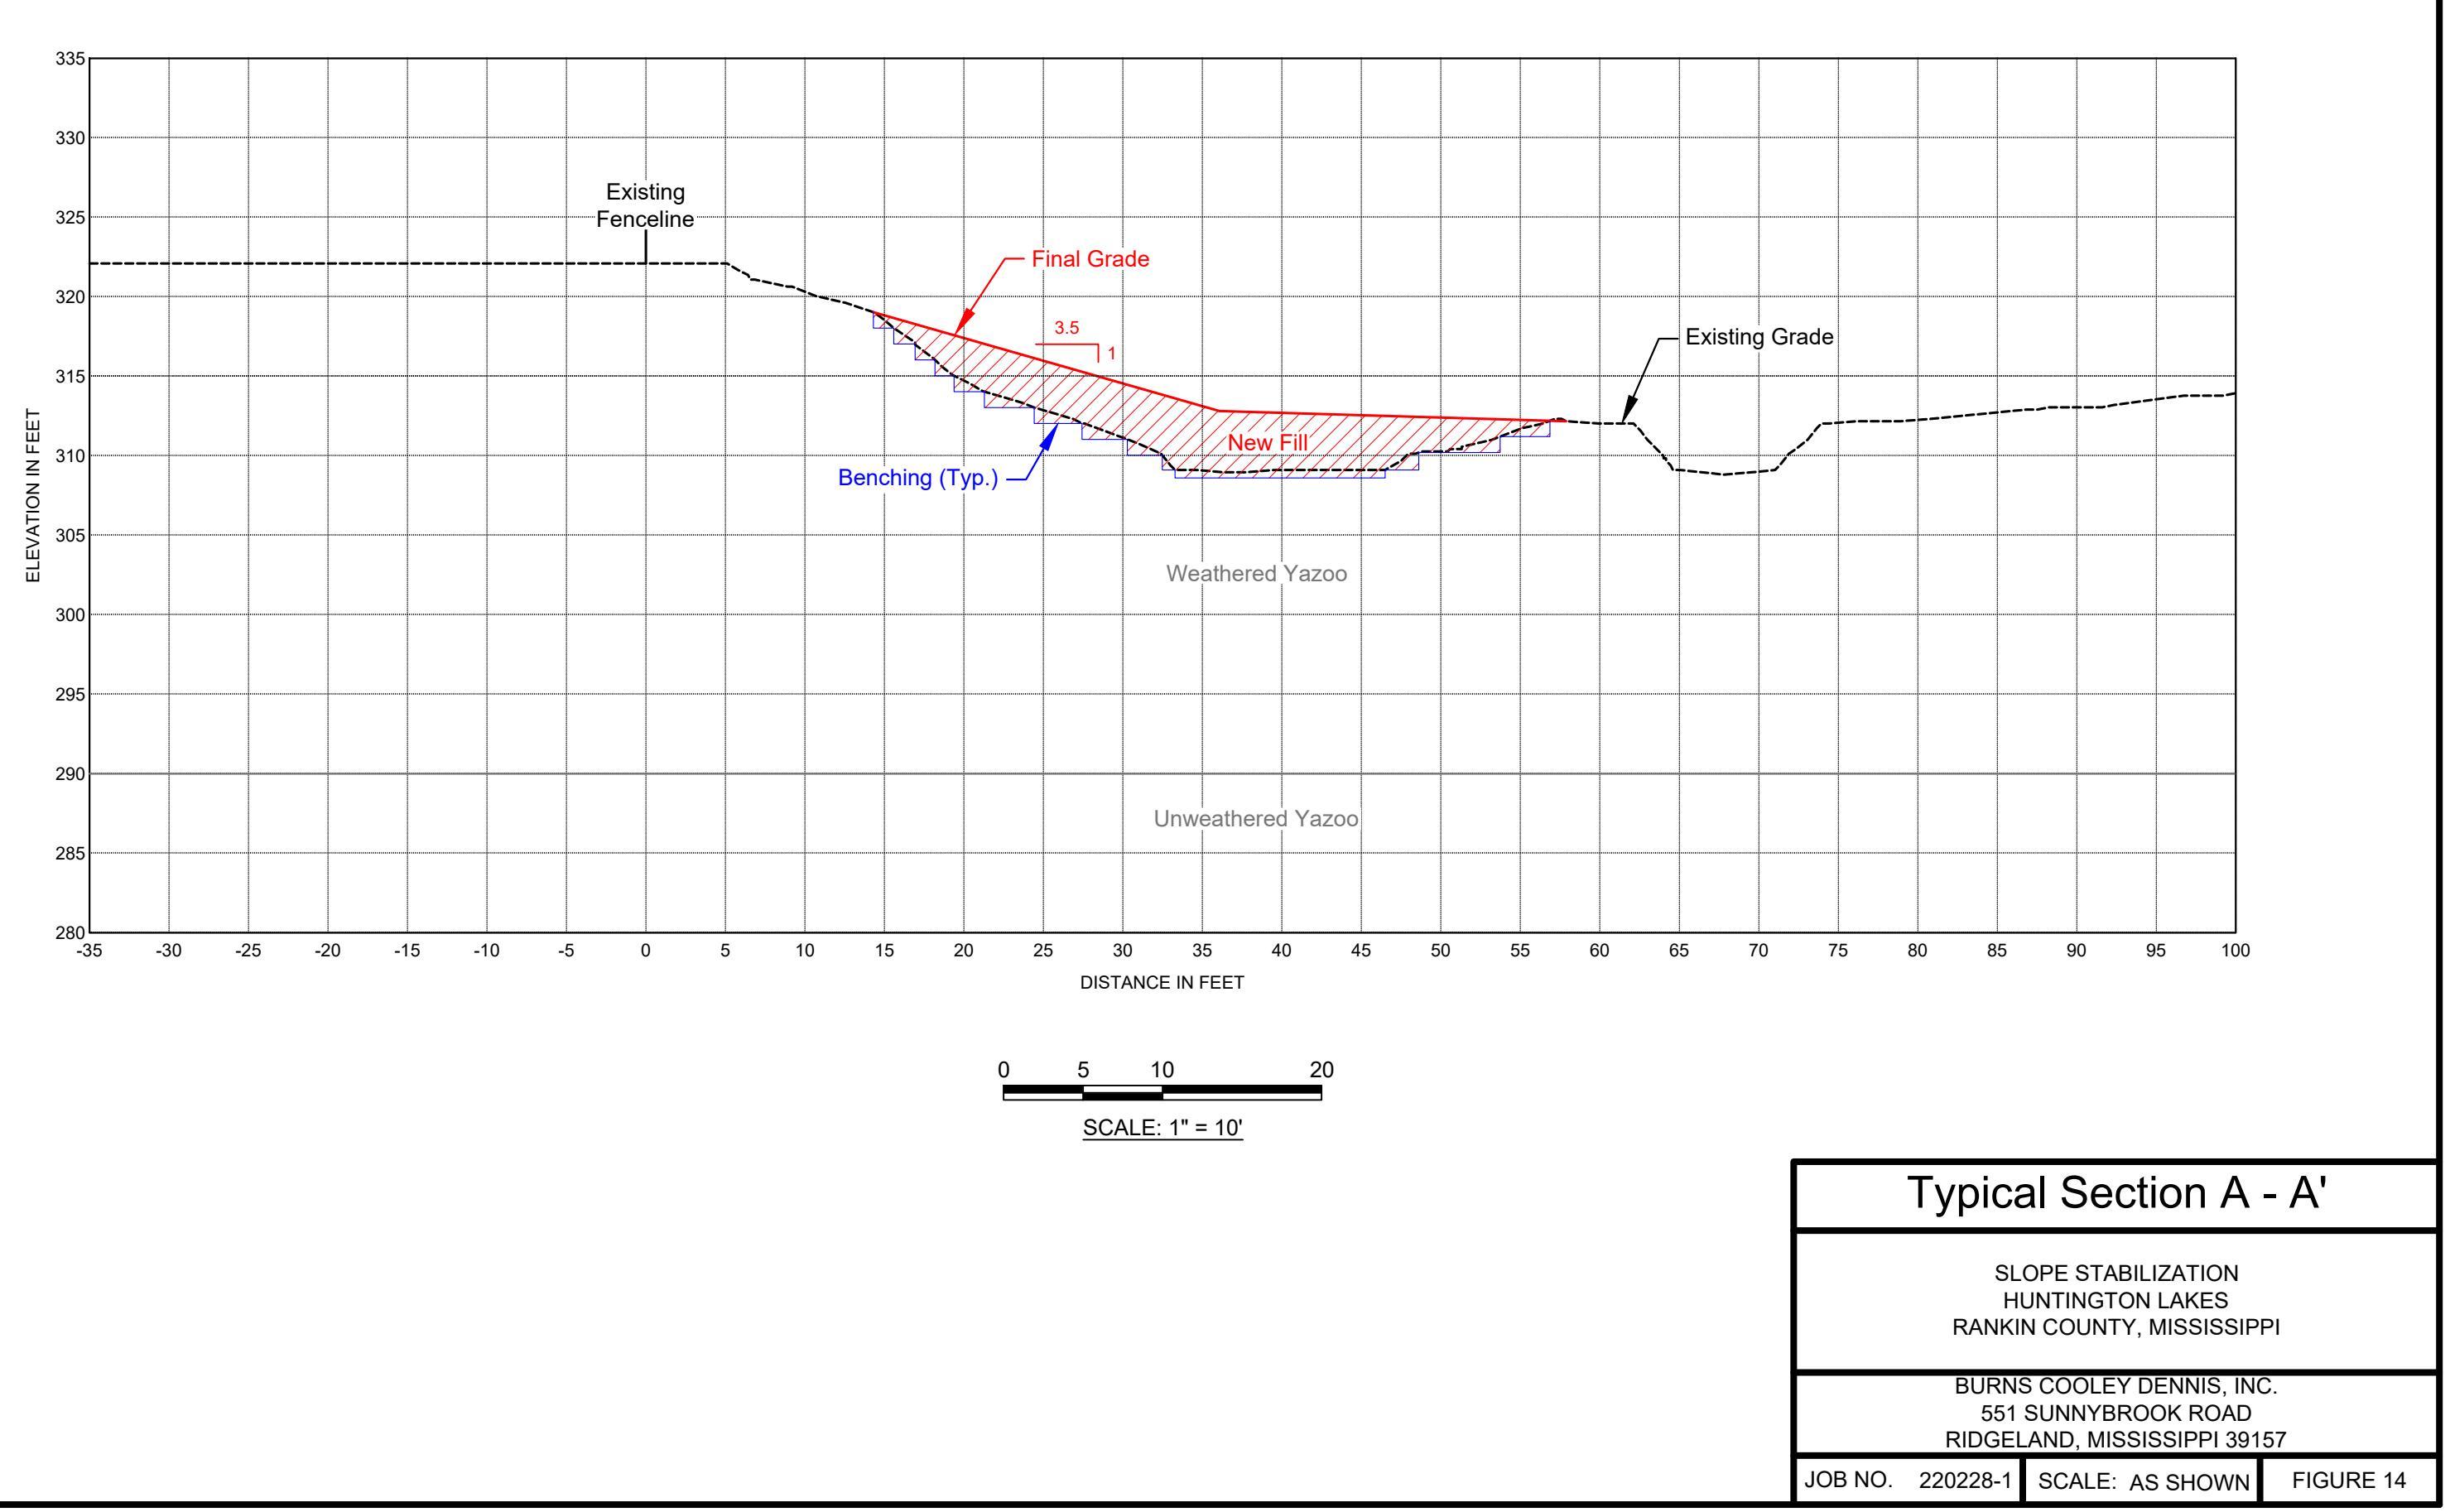
5.3 Remediation of Scour Hole – Section A-A'

Our slope stability analyses of Section A-A' indicate that the scour hole on the west bank of the south dam could be repaired by reconstructing the slope to approximately 1V:3.5H and by filling in the scour hole to raise the grade to above the previous dam crest height. The stability analyses results for the proposed reconstruction are presented on Figure 10.

Prior to reconstructing the slope, any disturbed soils, slide debris, vegetation, topsoil, weak soils, and muck should be removed. The excavation should extend upslope of any visible surface cracks and down to natural, undisturbed soils at the bottom of the gulley. Figure 14 shows a typical section of the proposed remediation at Section A-A'. A slope flatter than 1V:3.5H can be used if space allows, which would provide a slightly higher factor of safety.
